**Flood Control Project Maintenance
Levee Inspections**

Fall 2014 Levee Maintenance Deficiency Summary Report

Reclamation District No. 2062 Stewart

Levee Inspection Report By Mile - Fall 2014

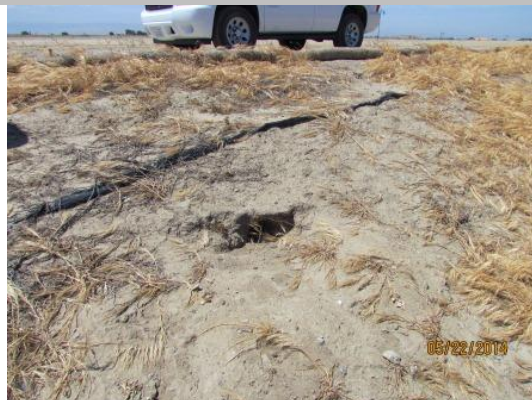
Photo 1 of 1 : FA_2014_RD2062_309_12_20141001_00005.jpg

| No rodents visible, but rodent burrows visible; need to backfill and compact or grout burrows. | | | | | |

View of a rodent hole on the waterside levee slope.

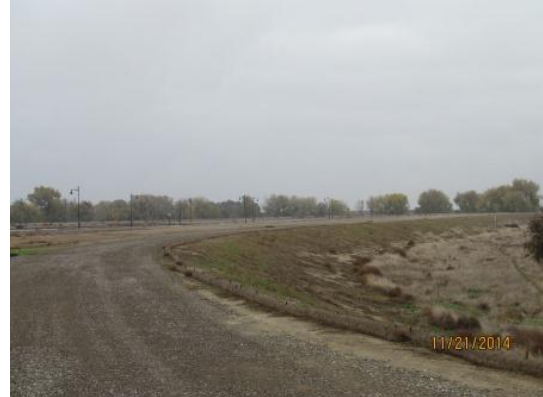
Photo 1 of 1 : FA_2014_RD2062_309_6_20141124_00007.jpg

View of acceptable vegetation control.

| Control annual grass and weeds on the levee slopes and easements. | | | | | |

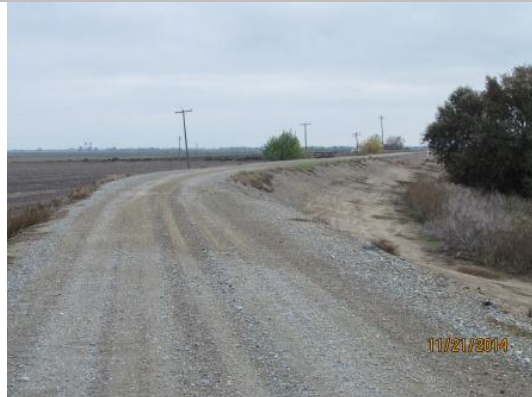
Photo 1 of 1 : FA_2014_RD2062_310_20_20141124_00022.jpg

View of acceptable vegetation control.

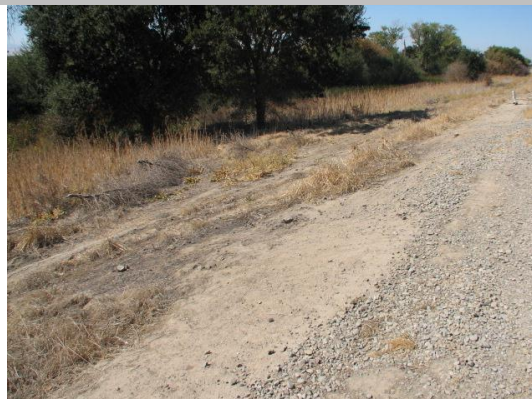
Photo 1 of 1 : FA_2014_RD2062_310_3_20141001_00003.jpg

Three small stumps on levee slope.

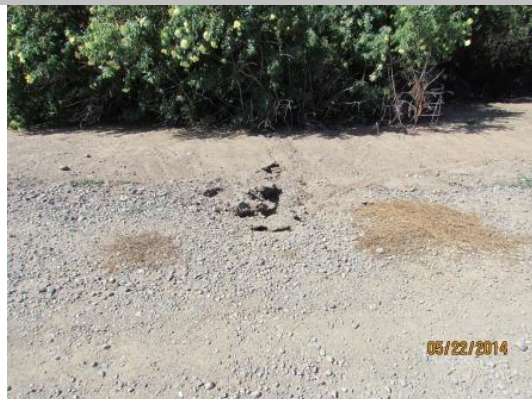
Photo 1 of 1 : FA_2014_RD2062_310_8_20141001_00004.jpg

View of the erosion from surface runoff on the waterside levee slope.

| Schedule repair of erosion site prior to the next inspection. | | | | | |

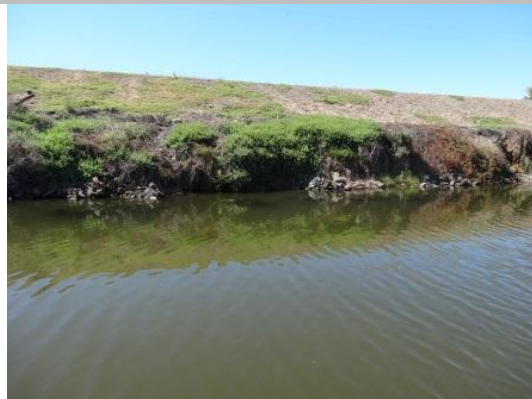
Photo 1 of 1 : SJR2014_RD2062U03RM29.93_1.jpg

| Inspector Comments: 07/02/2014: No significant change observed. 08/13/2013: No significant change observed. 08/07/2012: The site has been visited by boat survey. No significant change observed 08/23/2011: Site is at the upstream of a drainage ditch. [2014 Site ID:RD2062U03RM29.93] | | | | | |

Front view of the erosion.

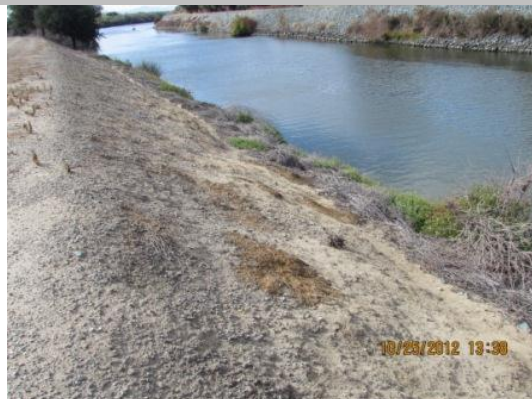
Photo 1 of 1 : FA_2014_RD2062_311_3_20141001_00003.jpg

| Tree stumps. | | | | | |

View of tree stumps on waterside slope.

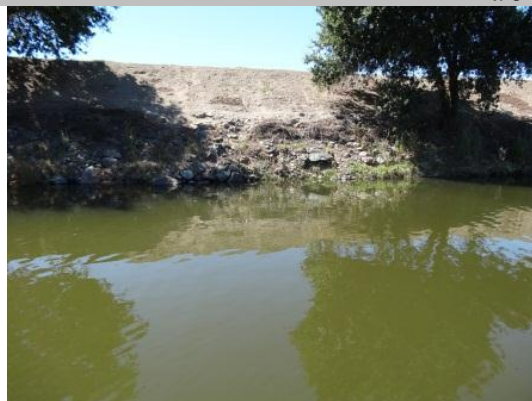
Photo 1 of 1 : SJR2014_RD2062U03RM30.02_1.jpg

| Inspector Comments: 07/02/2014: No significant change observed. 08/13/2013: No significant change observed. 08/07/2012: The site has been visited by boat survey. No significant change observed 08/23/2011: Hard to view the erosion because of the dense vegetation and trees on site. The site is under the bush, close to the tree. [2014 Site ID:RD2062U03RM30.02] | | | | | |

Front view of the site.

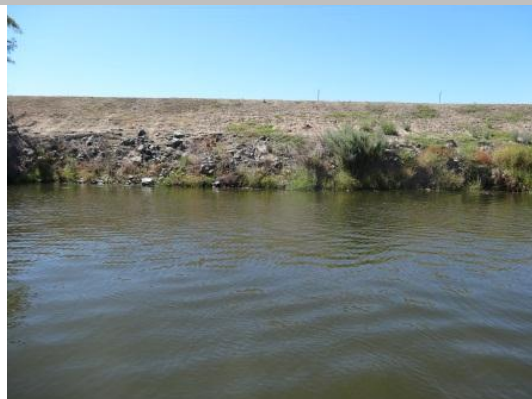
Photo 1 of 1 : SJR2014_RD2062U03RM30.1_1.jpg

| Inspector Comments: 07/02/2014: No significant change observed. 08/13/2013: No significant change observed. 08/07/2012: The site has been visited by boat survey. No significant change observed 08/23/2011: The protection at the levee toe has been washed away. [2014 Site ID:RD2062U03RM30.1] | | | | | |

Direct view of the site.

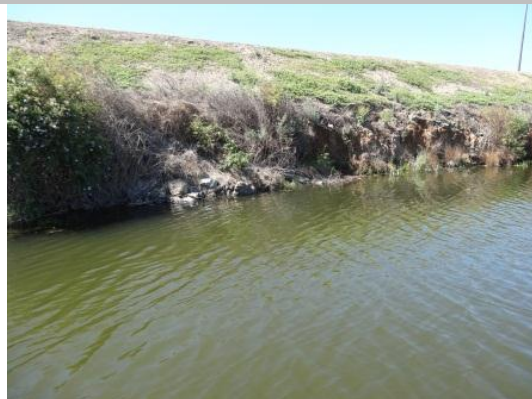
Photo 1 of 1 : SJR2014_RD2062U03RM30.19_1.jpg

Inspector Comments: 07/02/2014: No significant change observed.
08/13/2013: A new pocket erosion at the upper levee slope has been found directly above a large tree. The erosion might have been caused by internal pipe leakage or surface runoff.
08/07/2012: The site has been visited by boat survey. No significant change observed
08/23/2011: No significant change observed on site. Dense vegetation is visible along the water line.
09/07/2010: No significant change observed on site. Much of the upper slope was recently cleared of vegetation by spraying. 4- to 6-foot vertical scarp and pocket erosions are lined along a span of 475 feet. In some sections, the vertical scarp encroaches into the levee prism. There is a lack of berm along this reach, exposing the levee slope to high flow velocities during normal and flood events.
08/06/2010: Recommended as local maintenance issue, per CLRO.
03/09/2010: As discussed with Michael Moncrief of MBK Engineers, the site will be 'addressed' later this year.

09/29/2009: No major change observed since last visit; pocket erosion and a vertical scarp forming; this site was combined with Site RM30.13 and 30.02 with a combined total erosion length of 475 feet; recommended as annual assessment and monitoring of the site, per CLRO CES Evaluation 2008 Report; previously rated "M".
11/05/2008: Top of vertical scarp has rip rap that appears to be sliding; rodent holes; existing toe rip rap. [2014 Site ID:RD2062U03RM30.19]

Front view of the site with dense vegetation.

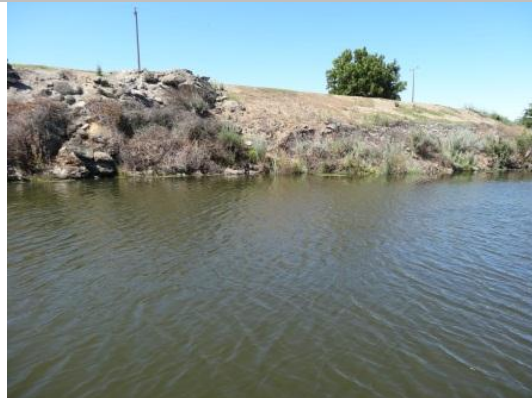
Photo 1 of 1 : SJR2014_RD2062U03RM30.27_1.jpg

Inspector Comments: 07/02/2014: No significant change observed.
08/13/2013: No significant change observed.
08/07/2012: The site has been visited by boat survey. No significant change observed
08/23/2011: The site is right at the downstream of a river bend. [2014 Site ID:RD2062U03RM30.27]

Front view of the erosion.

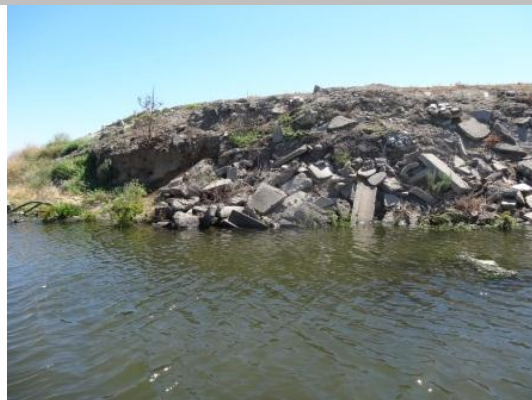
Photo 1 of 1 : SJR2014_RD2062U03RM30.43_1.jpg

Front view of the site. Rip rap no longer adequately protecting levee slope.

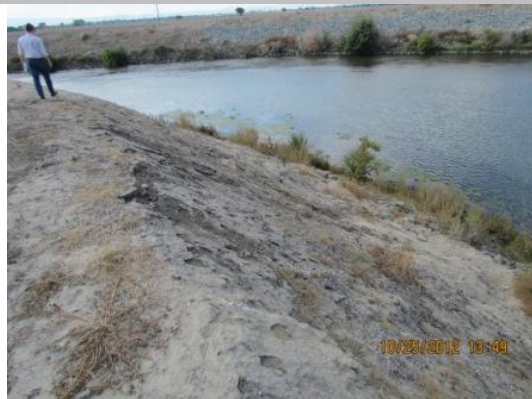
Photo 2 of 2 : FA_2014_RD2062_311_11_20141001_00011.jpg

| Schedule repair of erosion site prior to the next inspection. Inspector Comments: Cracking developing along the waterside levee hinge. | | | | | |

View of slope erosion from foot traffic.

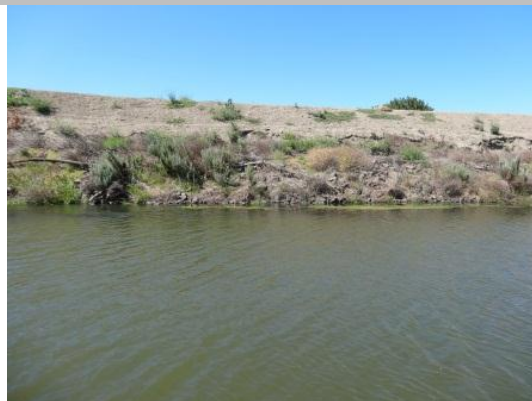
Photo 1 of 1 : SJR2014_RD2062U03RM31.12_1.jpg

| Inspector Comments: 07/02/2014: No significant change observed. 08/13/2013: No significant change observed. 08/07/2012: The site has been visited by boat survey. No significant change observed 08/23/2011: No significant change observed on site. 09/07/2010: No significant change observed on site. Much of the seasonal grass along the slope was cleared. Site consists of an existing scalloped erosion approximately 30 feet long by 5 feet wide at its widest opening. The lateral crack is extended outwards along the middle slope. There is a 1 to 2 feet of differential settlement that could further develop into a shallow slide. 08/06/2010: Recommended as local maintenance issue, per CLRO. 03/09/2010: As discussed with Michael Moncrief of MBK Engineer, site will be 'addressed' this year. 09/28/2009: No major change observed; section of rip rap has slipped, creating a terraced effect; dense vegetation growth; recommended as a local maintenance issue, per CLRO CES Evaluation 2008 Report; Site # is the same as RM31.12, LM1.25; previously rated "U". 09/14/2006: 1-2' into prism. [2014 Site ID:RD2062U03RM31.12] | | | | | |

Front view of the site.

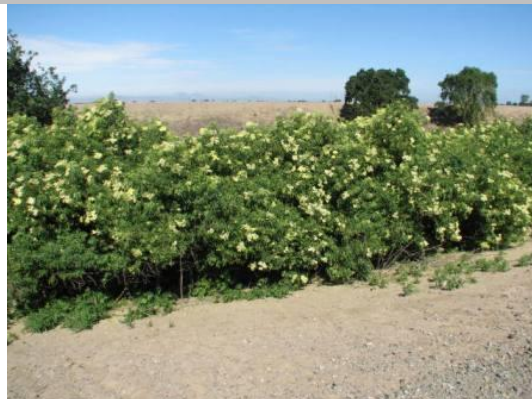
Photo 1 of 1 : FA_2014_RD2062_311_18_20141001_00015.jpg

| Elderberries are blocking visibility and flood fight capability. Inspector Comments: Elderberry bush blocks visibility. | | | | | |

05/11/2011 Elderberry bush on water side slope.

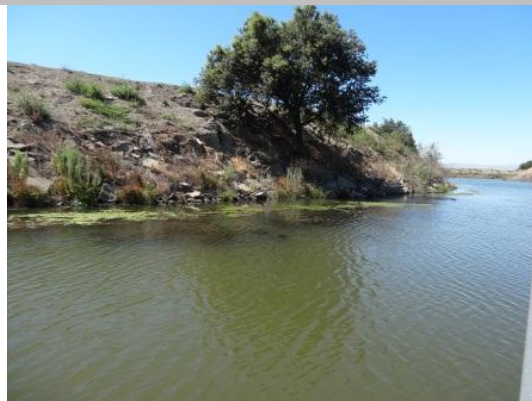
Photo 1 of 1 : SJR2014_RD2062U03RM31.28_1.jpg

| Inspector Comments: 07/02/2014: No significant change observed. 08/13/2013: No significant change observed. 08/07/2012: The site has been visited by boat survey. No significant change observed 08/23/2011: No significant change observed on site. 09/07/2010: No significant change observed on site. There is a small-to medium sized Oak tree on the mid-slope just above rip rap. Some of the rip rap has collapsed, creating a pocket erosion just above the existing toe rip rap and upstream of the Oak tree. 08/06/2010: Recommended as local maintenance issue, per CLRO. 03/09/2010: As discussed with Michael Moncrief of MBK Engineer, site will be 'addressed' in 2010. 09/29/2009: No major change since last visit; sliding of the rip rap at the base of the lone tree; there is noticeable man-made trail and foot traffic extending from the crown to the toe; much of the broken concrete used as temporary rip rap has slid, exposing portion of the bare levee slope; recommended as local maintenance issue, per CLRO CES Evaluation 2008 Report; Site # is the same as RM31.3, LM1.45; previously rated "M". 11/05/2008: Portion of rip rap collapsing. 09/14/2006: Portion of rip rap along the slope has collapsed; exposed levee section is starting to erode, exposing roots from the nearby tree. [2014 Site ID:RD2062U03RM31.28] | | | | | |

Front view of the site.

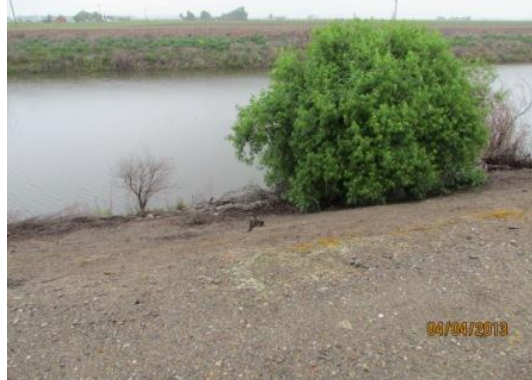
Photo 1 of 1 : FA_2014_RD2062_311_15_20141001_00014.jpg

| Tree stumps. | | | | | |

View of the tree stump on the waterside levee slope.

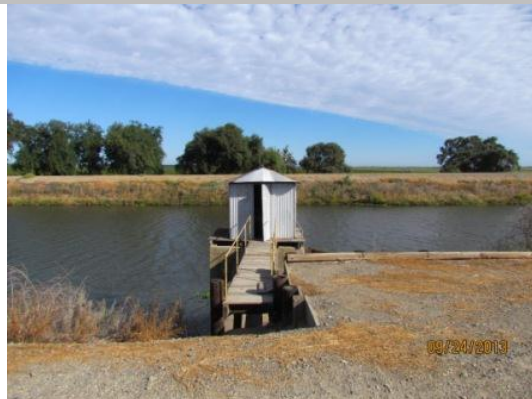
Photo 1 of 1 : FA_2014_RD2062_311_19_20141001_00016.jpg

| Pipe Inspector Comments: Irrigation intake. | | | | | |

View of the pump house on the waterside levee slope.

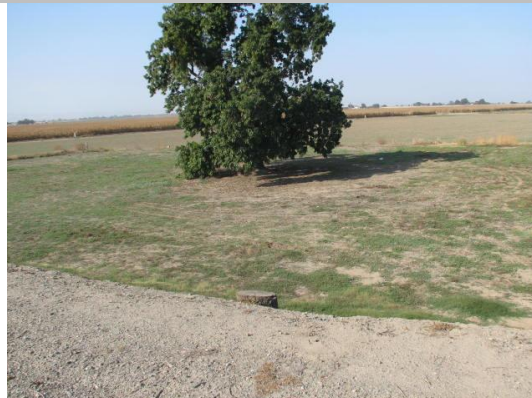
Photo 1 of 1 : FA_2014_RD2062_311_7_20141001_00006.jpg

| Inspector Comments: 14" stump on landside slope. | | | | | |

10/21/2011 Photo taken the next day. Stump can be seen in the lower center of the photo.

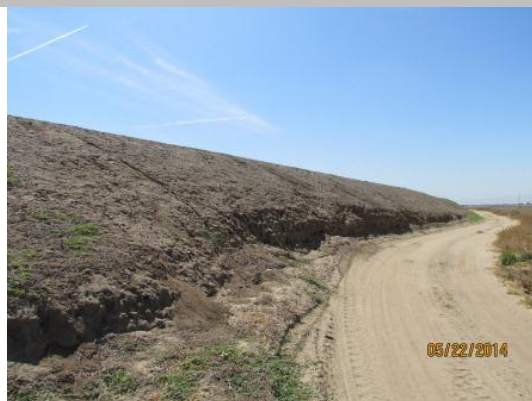
Photo 1 of 1 : FA_2014_RD2062_311_35_20141001_00020.jpg

| Note and monitor erosion site. Inspector Comments: 2 to 3 feet vertical cut possibly caused by previous floods. | | | | | |

View of a 2-3 feet vertical cut at the landside levee toe.
